Inspection Technique for CUI (Corrosion under Insulation) by Using Fiber Optical AE Sensor

Sumitomo Chemical Co., Ltd.

Process & Production Technology Center

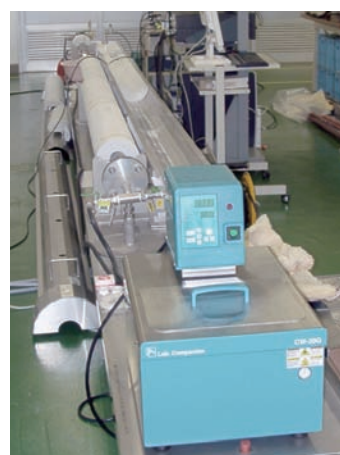
Fig. 1 Photo of the mock-up pipe

Technology Center since 2007. In 2007, we fabricated a mock-up pipe (pipe simulation) as shown in **Fig. 1** and conducted an investigation into applying detection of corrosion swelling using a fiber optic acoustic emission (AE in the following) sensor. Starting in 2008, we began working on the development of environmental noise separation techniques that included on-site applications. In 2008, we also investigated insulation structures for corrosion resistance (exterior plate structures), and we have carried out investigations into the selection of optimal undercoating materials for a temperature range of 60°C to 100°C. We continued these investigations in 2009, but we will discuss the status of development of inspection methods using fiber optic AE sensors here.

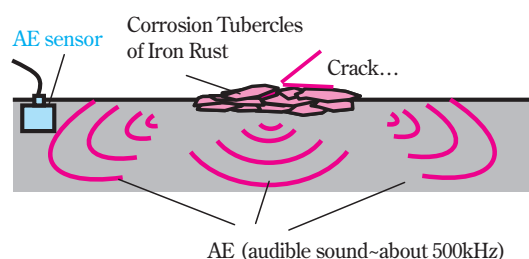
We focused on the relationship between corrosion and AE to establish an inspection method that was effective for pipe CUI. Fig. 2 is a conceptual diagram of the AE generating mechanism. First of all, peeling and cracking of local corrosion products (corrosion swelling) occur because of the progress in active corrosion. At this time, the strain energy that has accumulated inside is released as minute elastic waves. Since these elastic waves are comparatively low frequency elastic waves from the audible to 500kHz, it is known for propagating in a wide range. Therefore, the presence of corrosion can be sensed by detecting the AE caused by the peeling and cracking of the corrosion using an AE sensor to detect the elastic waves as AE. In other words, we can consider improving the CUI inspection efficiency by tearing down the insulation and carrying out visual inspections only on pipes where AE has been observed.

Fig. 2 Image of AE technique

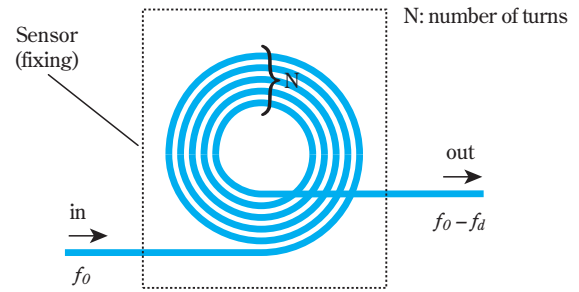
In other words, we can detect the strain (elastic waves, changes in stress, etc.) applied to the optical fiber by reading the frequency modulation f_d of the optical fiber. Fiber optical Doppler sensors have been developed for sensors that make use of the Doppler effect when these optical fibers expand and contract (see Fig. 4). To increase the sensitivity of these sensors and make reception from all directions possible, the optical fiber is wound into a coil; therefore, it has the char-

acteristics of being able to obtain an output proportional to the rate of expansion and contraction of the fiber, having a broad receiving band of 1 Hz to 1 MHz and having a broad temperature range of -200°C to 250°C .

Fig. 4 Principle of FOD sensor

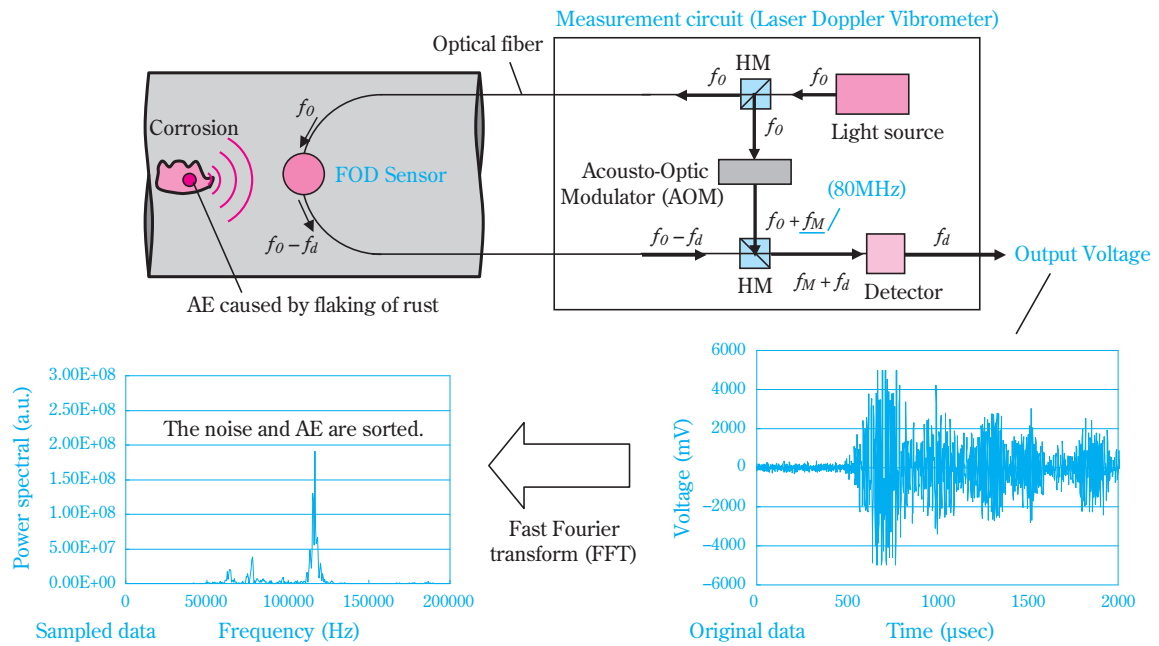
Fig. 5 is a conceptual diagram of a fiber optic AE monitoring system for pipe CUI. First, frequency f_0 lightwaves from a laser Doppler vibrometer light source in a measurement circuit are introduced into the optical fiber. The frequency of the lightwaves that are incident to the fiber optical Doppler sensor receive the AE arising because of the corrosion flaking and cracking and are modulated to f_0 through f_d . On the other hand, the amount of frequency modulation is detected using the heterodyne interferometric method. Specifically, a reference light with frequency f_M (80MHz) is added using a frequency modulator (AOM), creating $f_0 + f_M$ modulation. Furthermore, the difference in frequency $f_M + f_d$ of the laser light from the sensor and the laser light from the measurement circuit is introduced and f_d is detected. It is converted to voltage V by a frequency-voltage converter and output. A frequency analysis (FFT) is used on the original waveform data obtained at this time, and it is converted into extracted data such that the horizontal axis is frequency and the vertical axis is spectral power. This waveform analysis is important as a technique for discriminating noise and the AE caused by corrosion.

Fig. 5 Image of optical fiber of CUI

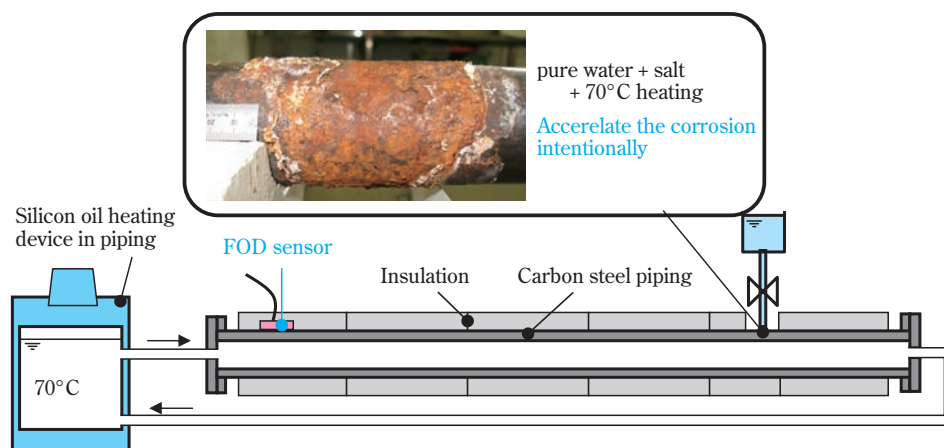
Up to now there have been actual records of fiber optic AE evaluations of areas with loosening base rock that accompanies underground storage tank excavation, but there are no records of use in CUI evaluations. Therefore, we fabricated mock-up piping like that shown in **Fig. 6** to investigate the possibilities of developing CUI inspection technology using fiber optic AE. Insulation was applied to a 5m carbon steel pipe, and heated silicon oil was circulated inside the pipe by a heating device. In addition, corrosion was accelerated artificially by pure water and salt where the amount dripped was finely adjusted to an extent giving rise to

wetting and drying to efficiently generate CUI and further by heating to 60 to 70°C using silicon oil. A fiber optical Doppler sensor is positioned at any location on this mock-up piping and data collected regarding AE from this corrosion site.

Fig. 6 Mock-up piping for CUI inspection investigation

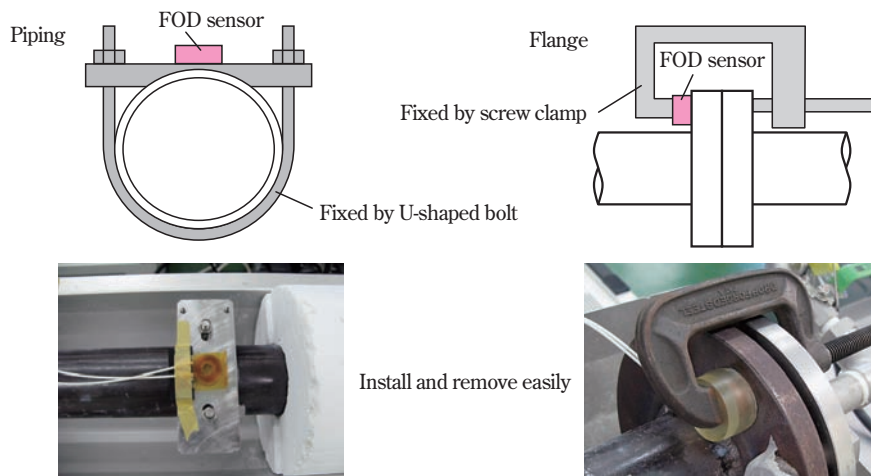
In this investigation, we used a commercial layered fiber optical Doppler sensor that was a 65m optical fiber wound into a layered coil shape (see **Fig. 7**). This sensor is characterized by having an increased sensitivity because the optical fiber is installed in a layered form. Even though it has a broad band, it has the same or greater receiving sensitivity than a narrow band conventional piezoelectric AE sensor. When the layered fiber optical Doppler sensor is installed on the piping, it

Fig. 7 FOD sensor installation

is secured using a U-bolt, and when it is installed on a flange, it is secured with a clamp. Either is extremely easy to install and remove, and like piezoelectric AE measurements, sending and receiving is possible through a commercial contact medium.

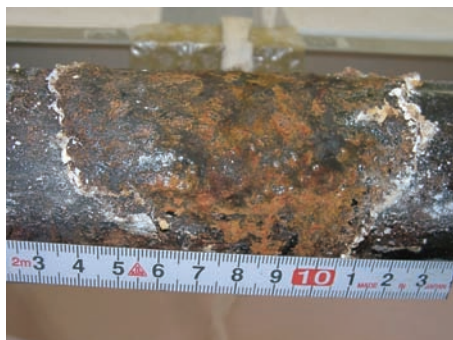
We carried out tests investigating AE detection in the initial stages of corrosion in November 2007. The state of corrosion on the piping at this time is shown in **Fig. 8**. Corrosion swelling has yet to arise, and the parts that look white are salt that has recrystallized. The fiber optical Doppler sensor was installed at a position 300mm from the site of the corrosion. The AE detection results are shown in **Fig. 9**. The bar graph shows the number of AE hits per hour, and the plotted line shows the cumulative AE hits.

Fig. 8 Corrosion of piping (1st monitor: 11/2007)

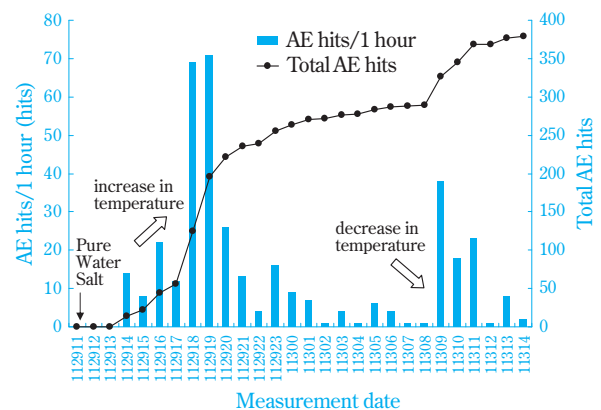
This proves that AE measurements are possible at initial stages of corrosion like this. In addition, there

Fig. 9 AE hits by initial corrosion

was an abrupt increase in AE after the start of the pure water and salt dripping and after the increase in temperature. In addition, the AE converges after a certain amount of time, and the AE increases when the oil temperatures lowered. The increase in the number of AE hits when the wetting and drying and changes in temperature are applied in this manner is a major characteristic of AE.

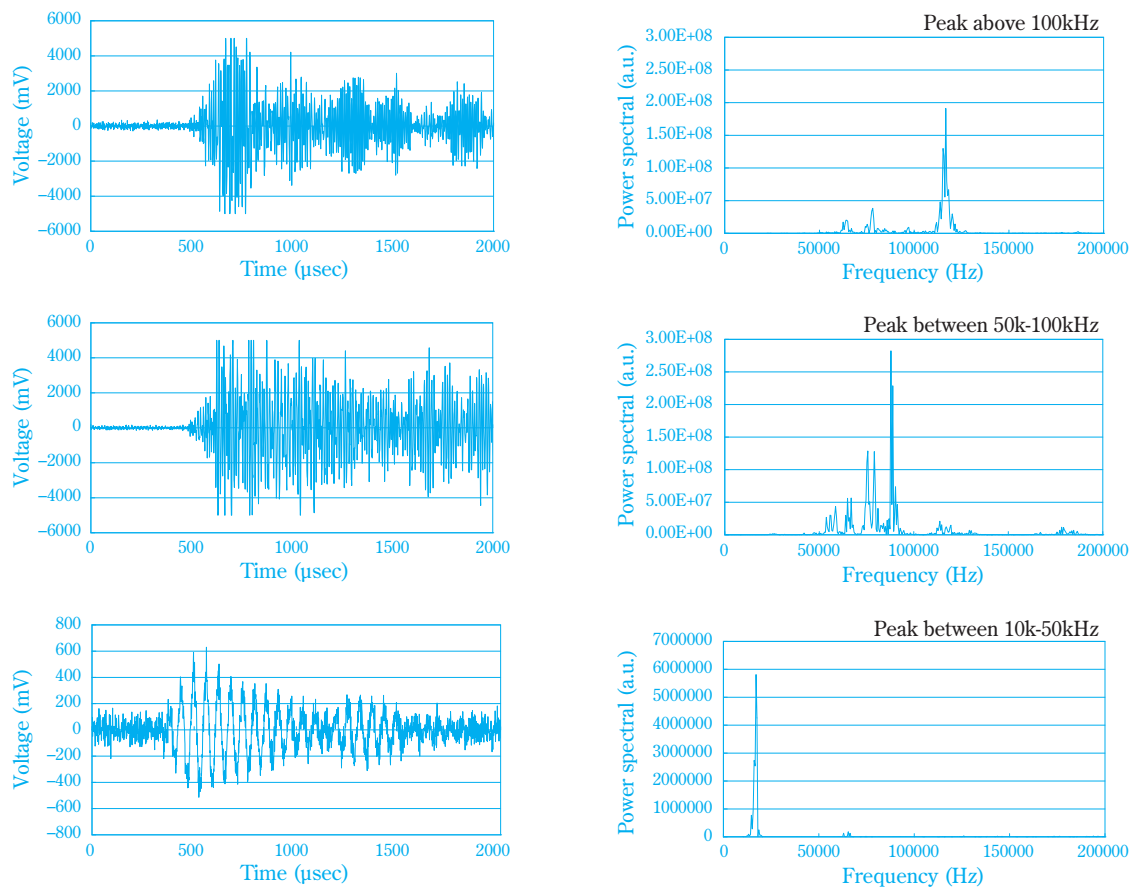
In addition, the AE waveforms recorded at this time are grouped into three patterns, ones that have frequencies exceeding 100kHz, ones at 50 to 100kHz and ones at 10 to 50kHz as shown in **Fig. 10**. These results can be said to be due to the fiber optic AE being able to receive a broad band. In measurements on actual equipment, it is important to selectively receive the AE in a frequency band from these three patterns of frequencies that does not overlap measurement noise. In addition, the lower the frequency for the AE, the further the propagation is, but since it is easy for management noise to arise on the low frequency side, it is necessary to measure the AE

Fig. 10 Data of original AE and Frequency spectrum pattern

pattern at as low a frequency as possible that does not overlap with the noise.

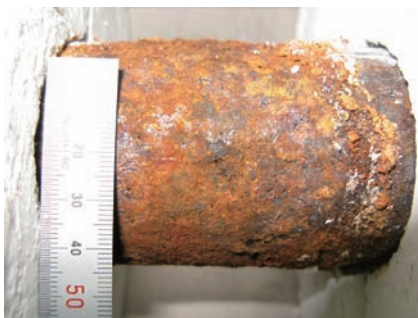
In January 2008 we conducted verifications of the distances at which AE could be detected. The state of corrosion on the piping at this time is shown in **Fig. 11**. Corrosion swelling has arisen, and in the progress of the corrosion can be seen. We installed the fiber optical Doppler sensor at positions 2,000mm, 3,000mm and

Fig. 11 Corrosion of piping
(2nd monitor: 01/2008)

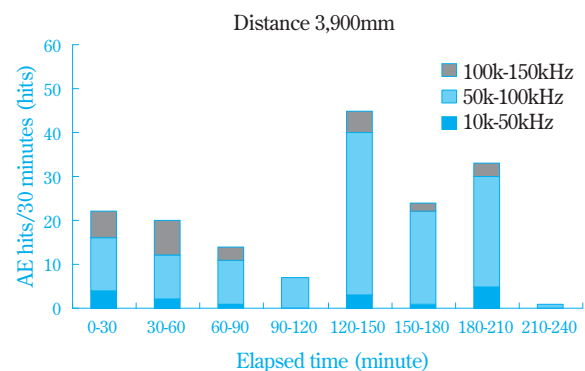
3,900mm from the site of the corrosion. **Fig. 12** shows the AE detection results at the 3,900mm position. In this manner we confirmed that it was possible to detect AE at a sufficient sensitivity even at maximum distance of 3,900mm. In addition, we found that the 50k to 100kHz frequencies were detected the most out of the three AE patterns. If no noise is present in this range of frequencies in measurements on actual equipment, which are a problem we will take up later, we can efficiently detect AE caused by corrosion.

Fig. 12 AE hits by corrosion progress at 3,900mm

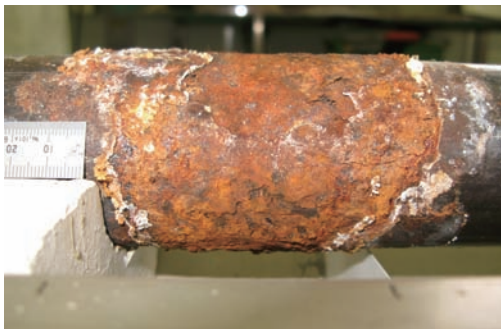
In March 2008 we compared AE detection on the piping and flange parts. The state of corrosion on the piping at this time is shown in **Fig. 13**. The corrosion swelling has grown further, and cracking heads appeared in part of the corrosion swelling. Fiber optical Doppler sensors were installed on the pipe at 3,900mm and on a flange part at 3,950mm from the site of the corrosion is shown in **Fig. 14**.

Fig. 13 Corrosion of piping (3rd monitor: 03/2008)

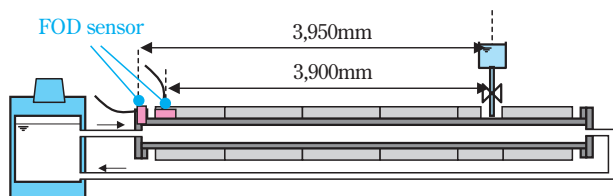
Fig. 14 The position of FOD sensor installation

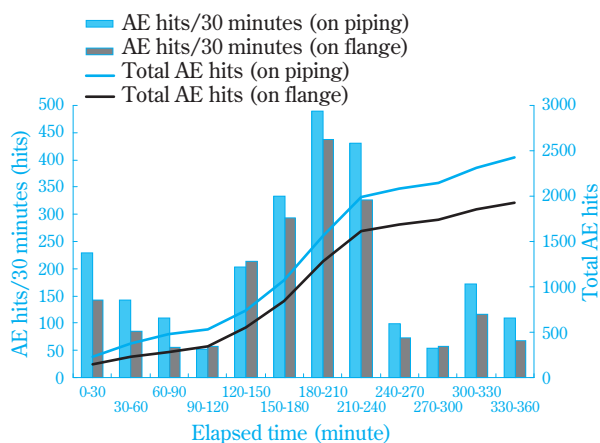
Fig. 15 shows a comparison of the results for AE detection on the piping and flange parts. While these results show poorer sensitivity than on the pipe itself, we

Fig. 15 Comparison of the situation of AE hits piping and flange

confirmed that there was excellent AE detection on the flange part. If it is possible to detect AE on the flanges, we can expect to only remove the insulation from the flange parts to make AE measurements.

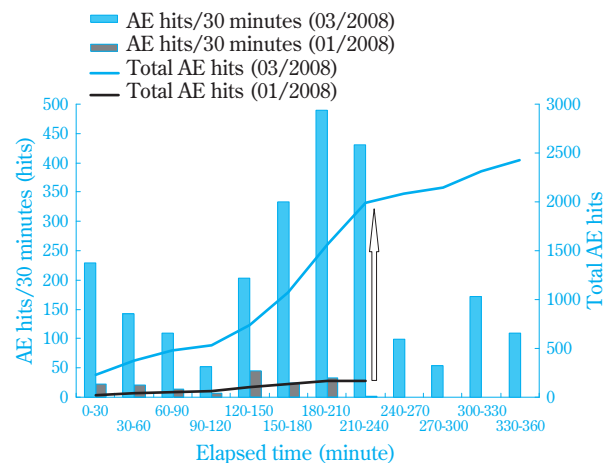
To make a comparison with the number of AE hits from the corrosion site in January 2008 and the number of AE hits from the corrosion site in March 2008 after the corrosion had progressed further, we installed a fiber optical Doppler sensor at the same 3,900mm position and compared the results of measurements. The results of that comparison are shown in **Fig. 16**. However, the AE measurements in January 2008 were only made up to 240 minutes. As is clear from this figure, we can see that the number of AE hits in March has clearly increased with the progress in the corrosion compared with those in January (an approximately tenfold AE hit number at 240 minutes). The AE method cannot quantify the area of the corrosion or depth of material reduction, but if the volume of the corrosion swelling increases, the probability of AE hits increases. Therefore, we can consider the possibility of evaluations using the degree of correlation with the progress of the corrosion by counting the number of AE hits.

Fig. 16 Comparison of the number of AE hits 01/2008 and 03/2008

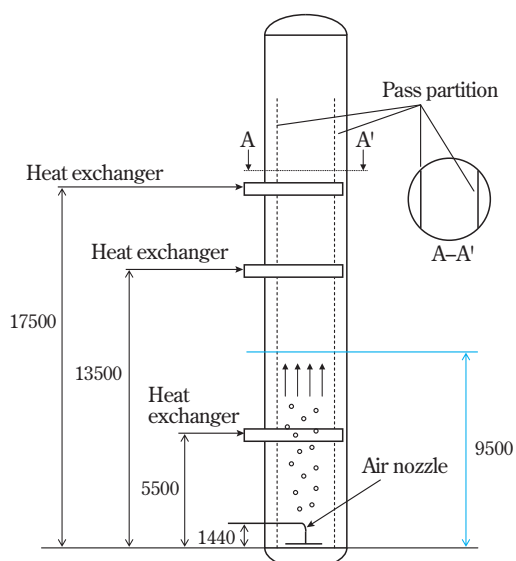
The positions for attaching the fiber optical Doppler sensors to the vertical reactor are shown in Fig. 17 and Fig. 18. Four (four channels) fiber optical Doppler sensors were attached at intervals of approximately 3,000mm with a pitch of 90° around the circumference positioned vertically at 9,500mm based on the girth line for the lower mirror and body of the main body of the reactor.

Fig. 17 Structure of the vertical reactor

pipes without tearing down insulation even if it cannot be called complete, but there is no method for equipment other than tearing down insulation and visual inspection. Therefore, we selected an operating vertical reactor (3.8m inside diameter, column length approximately 28m) where CUI might be revealed as the equipment to be targeted for measurements. There was a plan for the insulation to be removed from the entire surface of the column in this equipment and to perform the work of eliminating the corrosion that had arisen due to CUI by surface preparation. Therefore, fiber optical Doppler sensors were installed along with this work, and after the corrosion had been removed, AE measurements were made. We investigated the separation of the AE from corrosion under conditions that included the environmental noise due to the fluid inside. Moreover, if a CUI inspection method that is more efficient than visual inspection is established for stationary equipment like vertical reactors, installation of scaffolding and tearing down the insulation will become unnecessary, which has great merit in terms of costs.

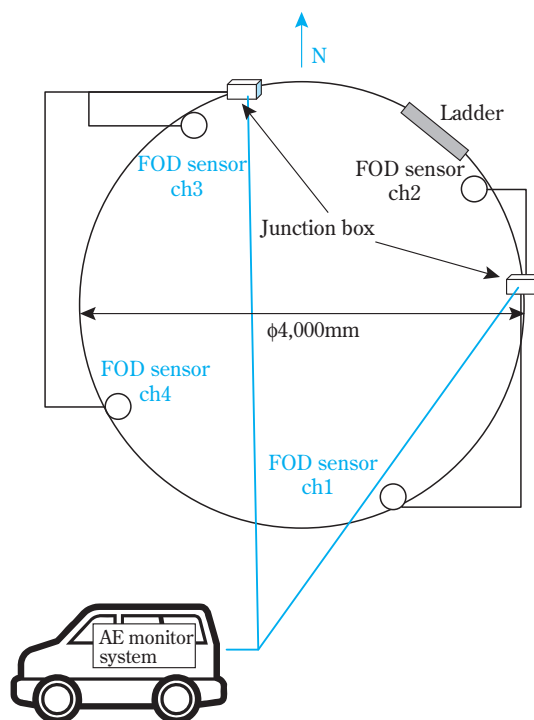
Fig. 18 The position of FOD sensor installation and wiring for signal cable

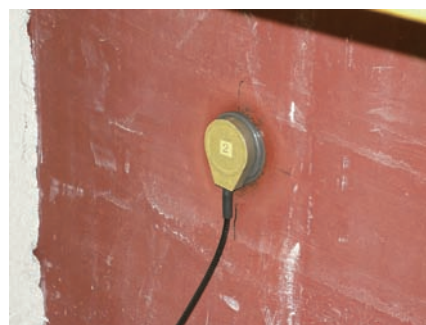
As is shown in Fig. 19, the fiber optical Doppler sensors were protected by a waterproof case. After the surface coating on the outside of the reactor was removed with sandpaper, they were glued using a heat resistant epoxy resin adhesive and secured from the top using aluminum tape. The signal cables extending from the fiber optical Doppler sensors were each collected in a jack box as ch1, ch2, ch3 and ch4 (see Fig. 20), and a cable was extended from there to the ground. When AE measurements are made, a terminal box installed on the aboveground part and a fiber optical Doppler interferometer installed in a vehicle are connected by a cable (see Fig. 21). One of the major merits of this method is that, once the fiber optical Doppler sensors are connected to the actual equipment, inspections can easily

Fig. 19 The condition of FOD sensor installation on the vertical reactor

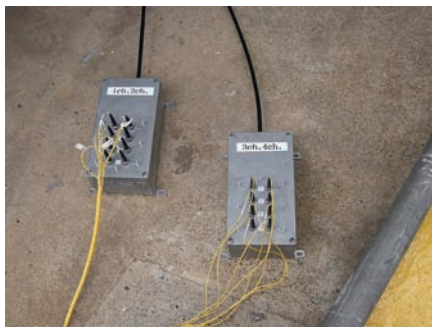
Fig. 20 Connection of 4ch FOD sensor to junk BOX

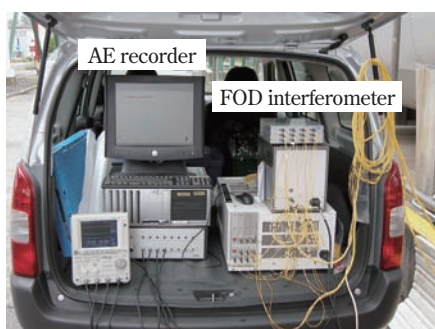
Fig. 21 AE measurement condition in which FOD interferometer and collection analysis device are loaded into car

be carried out from the aboveground part which is at a distance from the sensors.

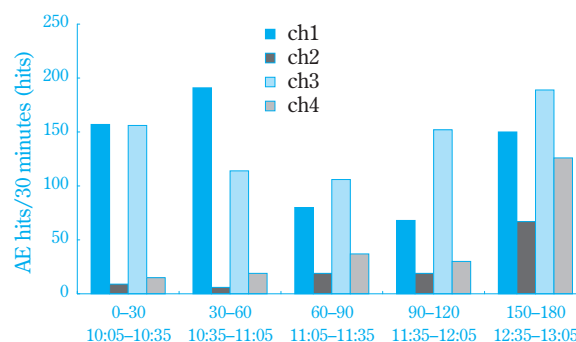
The results of AE measurements before and after the removal of the corrosion due to CUI that had arisen on the equipment by surface preparation are shown in **Fig. 22** and **Fig. 23**, respectively. As a result, a large amount of AE was detected in the state where the corrosion due to CUI was present, and after the corrosion had been removed, the number of AE hits was reduced to approximately 1/10. Therefore, we assumed that we were also able to detect AE that can be thought of as being caused by corrosion on actual equipment. In addition, there was also a large difference in the number of AE detections by each of the sensors before removal of the corrosion. In visual inspections after the insulation was removed, multiple corrosion sites were found to be present in the vicinity of the sensors where there were many AE detections. In this manner, we were able to confirm that there was a good correlation between the state of corrosion and the state of AE detection in tests carried out using actual equipment.

Fig. 22 AE hits/30 minutes before removing rust

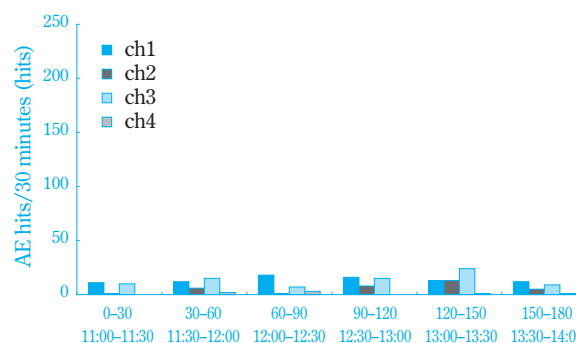
However, the AE shown in **Fig. 23**, which was detected after the removal of the corrosion, is not caused by corrosion. It can be assumed to be environmental noise that could not be eliminated by filtering using current waveform processing techniques. Being able to separate out this environmental noise as precisely as possible is extremely important for using this technology at actual sites.

Fig. 23 AE hits/30 minutes after removing rust

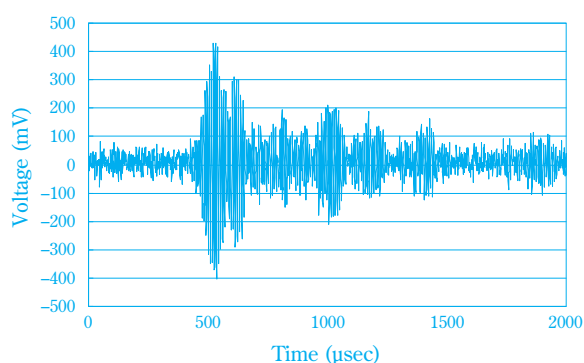
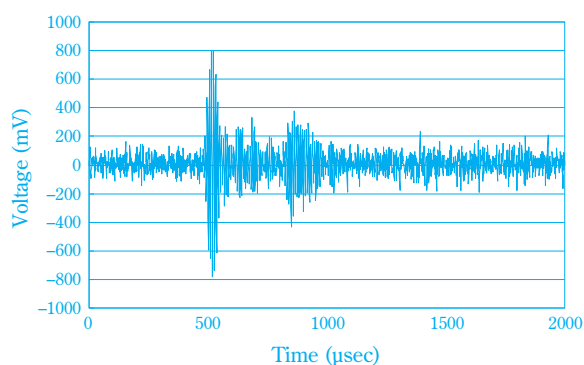
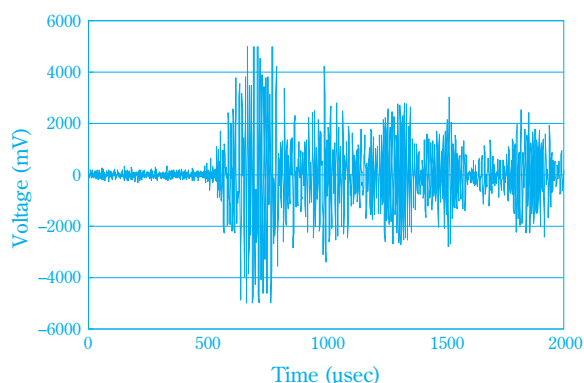
The typical AE waveforms detected before and after the removal of the corrosion and the AE waveforms from corrosion that were obtained in the investigations with the CUI mock-up piping are shown in **Fig. 24** through **Fig. 26**, respectively. Since the rise of the waveforms, the duration, etc. have a very similar shape, it can be assumed that separating the environmental noise out using the shape of the waveforms will be difficult.

Fig. 24 Representative Waveform of AE obtained before removing rust

Fig. 25 Representative Waveform of AE obtained after removing rust

Fig. 26 Representative Waveform of AE obtained from mock-up piping

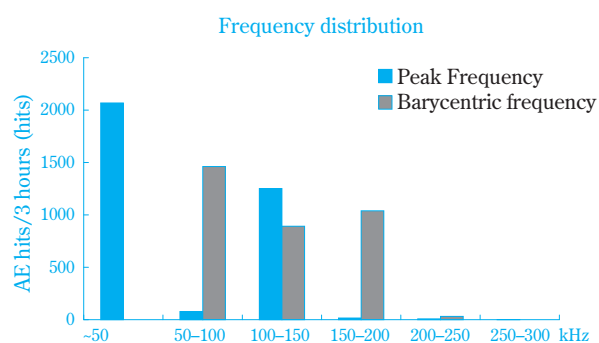
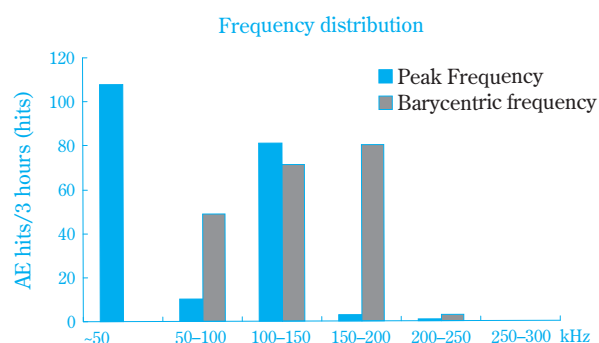
Next, the frequency distributions for the peak frequency (frequency with the largest amplitude in the frequency spectrum) and the barycentric frequency (frequency that is the center of gravity for the area of the frequency spectrum) for a measurement time of three hours of AE detected before and after the removal

of the corrosion are shown in **Fig. 27** and **Fig. 28**. Both of the frequency bands are substantially the same as the corrosion AE frequency band (10kHz to 150kHz) obtained in the investigations with the CUI mock-up piping. In addition, since the frequency distributions for the AE peak frequency and the barycentric frequency before and after the removal of the corrosion have very similar distribution shapes, it can be assumed that environmental noise separation by frequency analysis will be difficult.

Fig. 27 Frequency distribution of AE obtained before removing rust

Fig. 28 Frequency distribution of AE obtained after removing rust

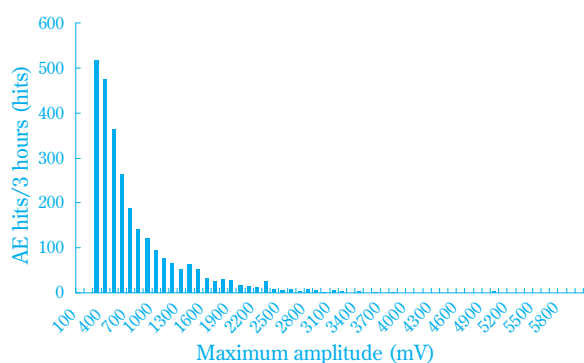
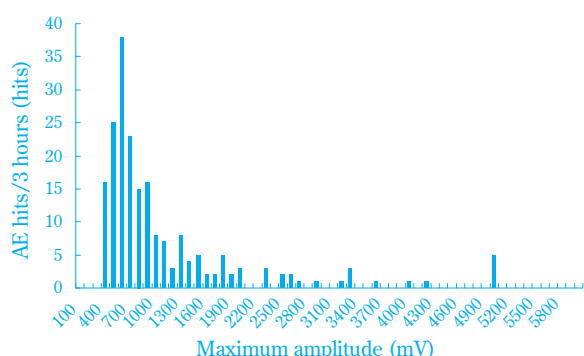
Next, the frequency distributions for the maximum amplitude and number of AE hits for a measurement time of three hours of AE detected before and after the removal of the corrosion are shown in **Fig. 29** and **Fig. 30**, respectively. There are many small maximum amplitudes for AE before the removal of the corrosion, and as the maximum amplitudes increase, the number of AE hits decreases. On the other hand, while the shape of the distribution for AE after removal of the corrosion is roughly similar to the AE before removal, a clearly significant difference can be seen in this frequency distribution instead of the small maximum amplitudes being the most common. Therefore, we attempted a comparison using the m value (shape parameter for the distribution function) to make a more easily understood numerical conversion for these results. The m value is the slope of the distribution graph line obtained when two axes in the graphs for the frequency distributions of the maximum amplitude and hits for AE shown in **Fig. 29** and **Fig. 30** are shown logarithmically. The corrosion AE m values obtained for the AE detected before and after the removal of the corrosion and in the investigations with the CUI mock-up piping are shown in **Fig. 31**.

Fig. 29 Distribution of AE hits and maximum amplitude obtained before removing rust

Fig. 30 Distribution of AE hits and maximum amplitude obtained after removing rust

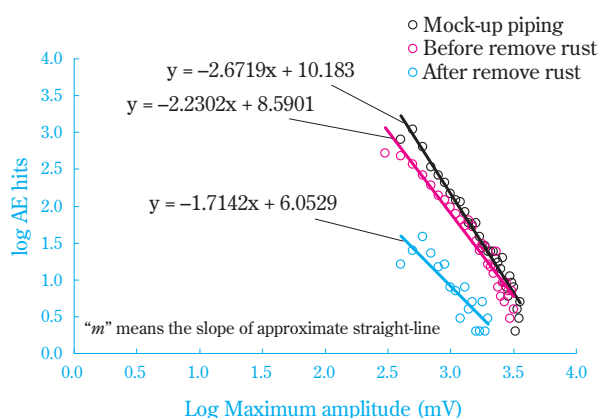
Fig. 31 Comparison by m value (Shape parameter)

In these results, the m values for AE before and after the removal of the corrosion were -2.23 and -1.71 , respectively, and the m value for the AE from the corrosion in the CUI mock-up piping was -2.67 . It was found that the AE frequency distribution before the removal of the corrosion was very similar to the AE frequency distribution from the corrosion on the CUI mock-up pip-

ing and that the frequency distribution of the AE after the removal of the corrosion differed. These results suggested that it would be possible to separate AE due to corrosion and the pseudo-AE due to the environmental noise by finding the m value.
